EMERGENCY ACTION PLAN

Gypsum Storage Area Cell #2

Gulf Clean Energy Center

Project No. 21482735

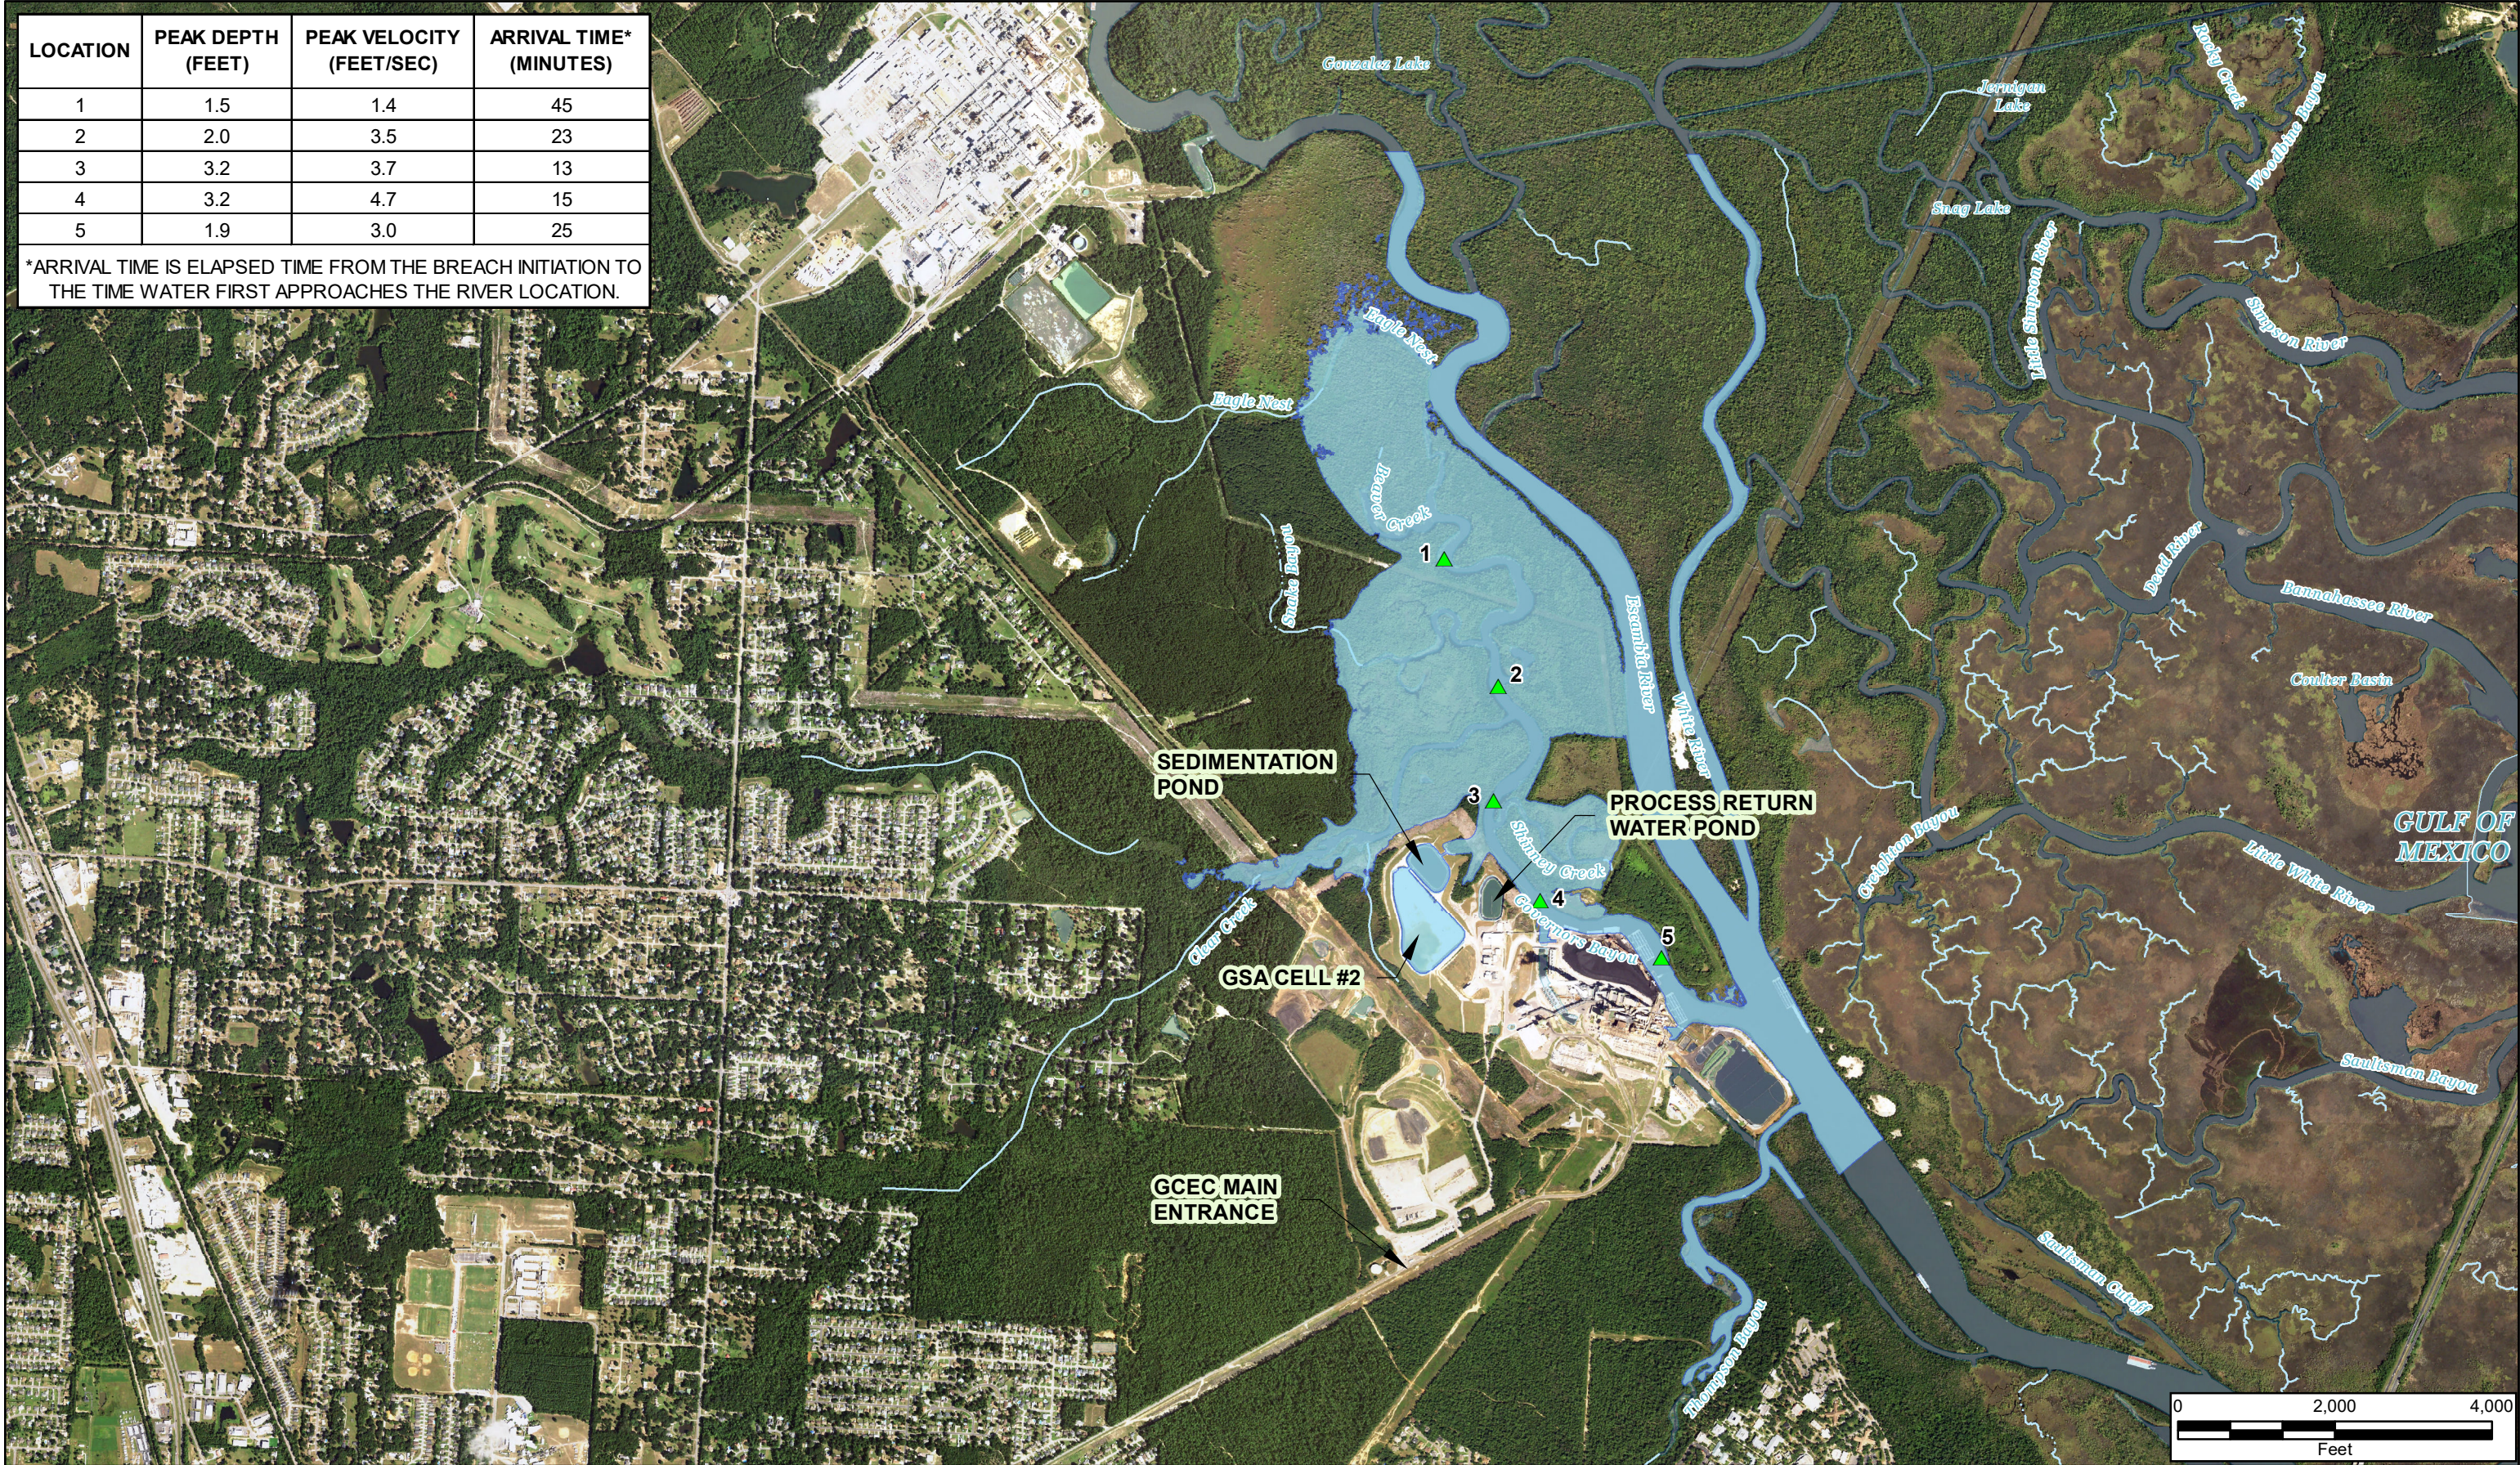
FIGURE
1A

LOCATION	PEAK DEPTH (FEET)	PEAK VELOCITY (FEET/SEC)	ARRIVAL TIME* (MINUTES)
1	1.5	1.4	45
2	2.0	3.5	23
3	3.2	3.7	13
4	3.2	4.7	15
5	1.9	3.0	25

*ARRIVAL TIME IS ELAPSED TIME FROM THE BREACH INITIATION TO THE TIME WATER FIRST APPROACHES THE RIVER LOCATION.

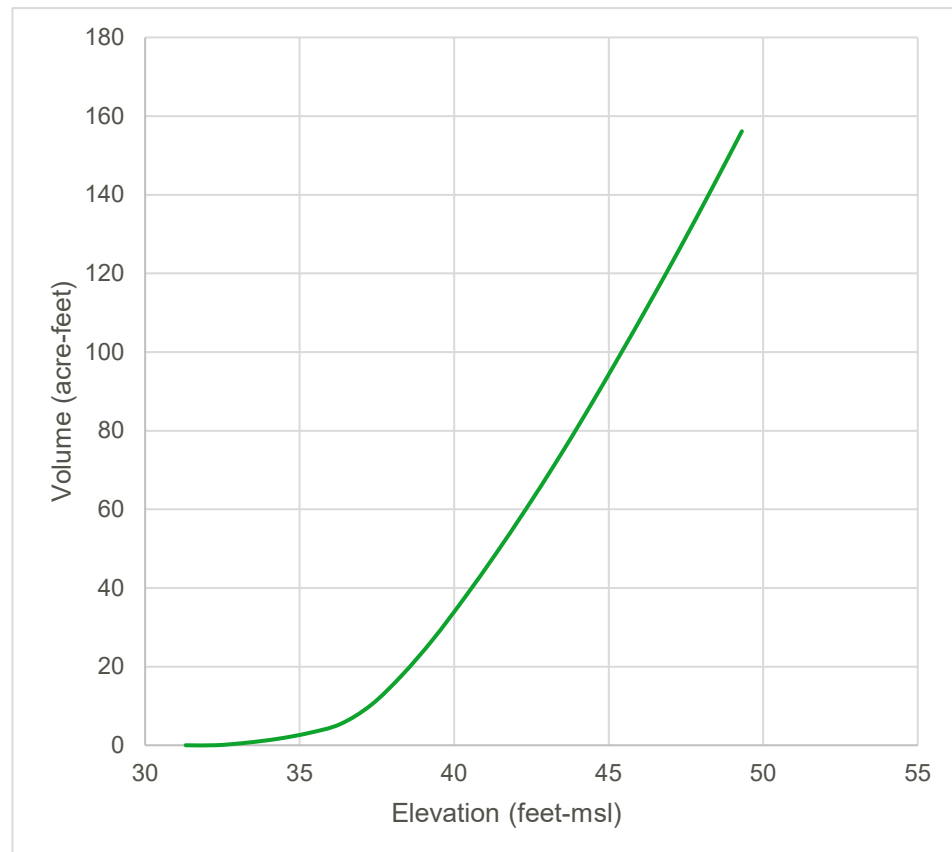
GYPSUM STORAGE AREA VOLUME - STAGE-AREA-STORAGE

Elevation (feet-msl)	Volume (acre-feet)
31.31	0.0
32.31	0.0
33.31	0.7
34.31	1.7
35.31	3.1
36.31	5.4
37.31	10.2
38.31	17.8
39.31	26.9
40.31	37.2
41.31	48.3
42.31	59.9
43.31	72.1
44.31	85.1
45.31	98.5
46.31	112.3
47.31	126.5
48.31	141.1
49.31	156.1

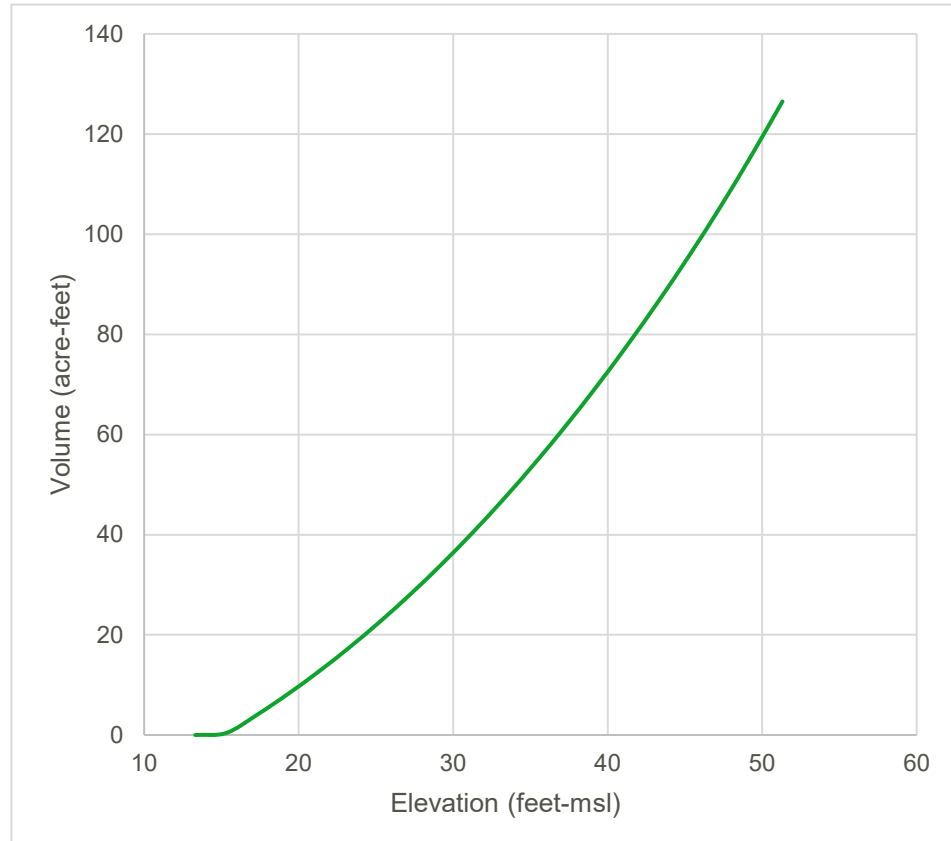
SEDIMENTATION POND VOLUME - STAGE-AREA-STORAGE

Elevation (feet-msl)	Volume (acre-feet)
13.31	0.0
15.31	0.4
17.31	4.0
19.31	8.2
21.31	12.7
23.31	17.6
25.31	22.8
27.31	28.3
29.31	34.3
31.31	40.6
33.31	47.3
35.31	54.4
37.31	61.8
39.31	69.7
41.31	78.0
43.31	86.7
45.31	95.9
47.31	105.6
49.31	115.8
51.31	126.5

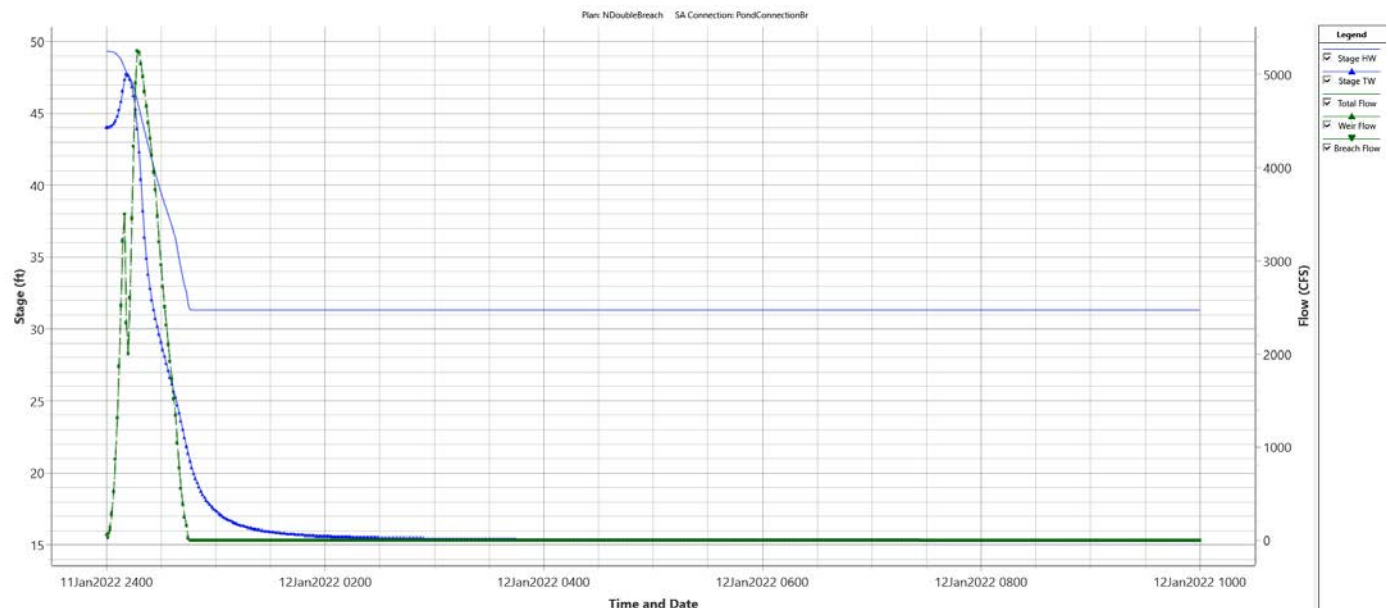
Gypsum Storage Area

Boundary Condition Normal depth; Slope = 0.00013
Equation Set Full Momentum
